**“Concrete Pavement Materials  
Testing and Petrography –  
Rehab/Repair or Replace?”**

**David Rettner, PE and Gerard Moulzolf, PG  
American Engineering Testing, Inc.  
St. Paul, MN and Bonita Springs, FL**

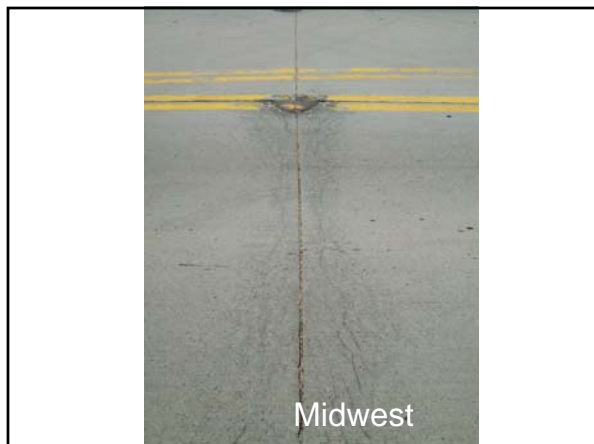
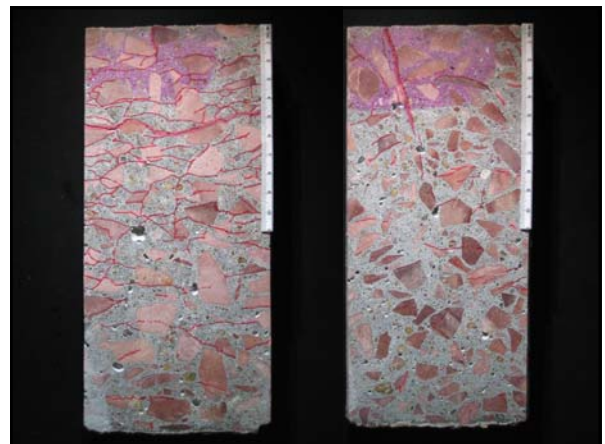
- Materials Issues
  - Marginal Air Void System
  - Aggregate Durability
  - Deicer Exposure
  - General Concrete Quality

Coring  
Petrography

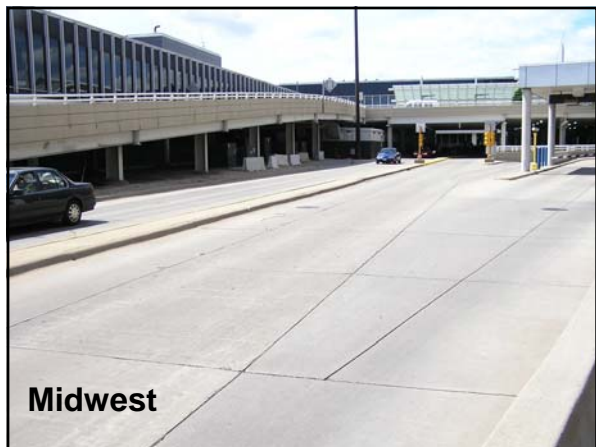
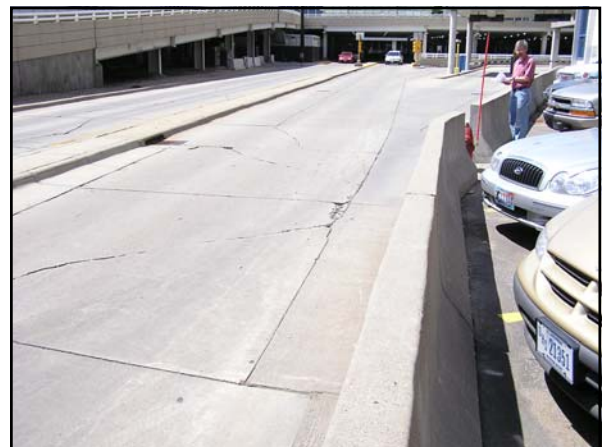
- Structural Problems
  - Faulting
  - Subgrade Settlement
  - Fatigue
  - Dowel Corrosion/Failure

Falling Weight Deflectometer and Ground Penetrating Radar

- Subgrade Strength
- Load Transfer
- Voids Under Slabs

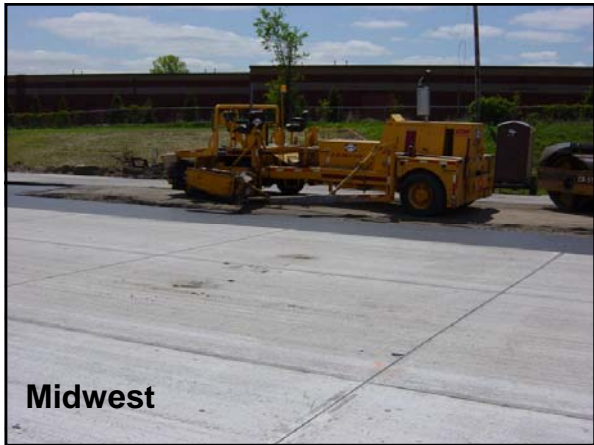
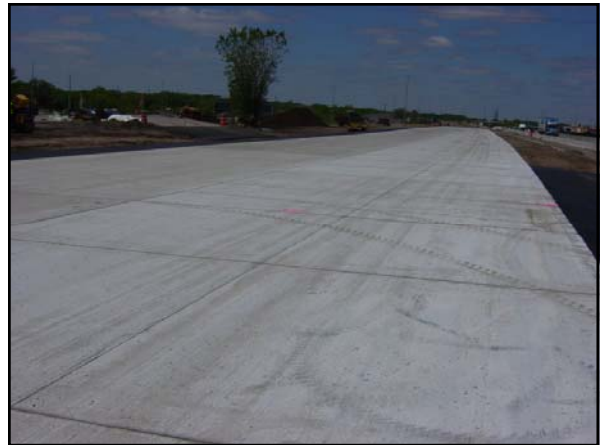
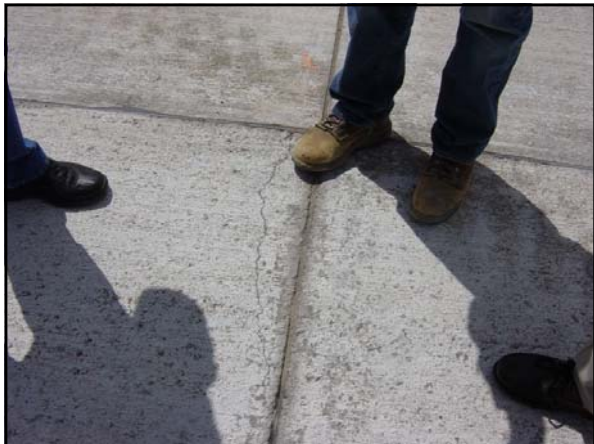
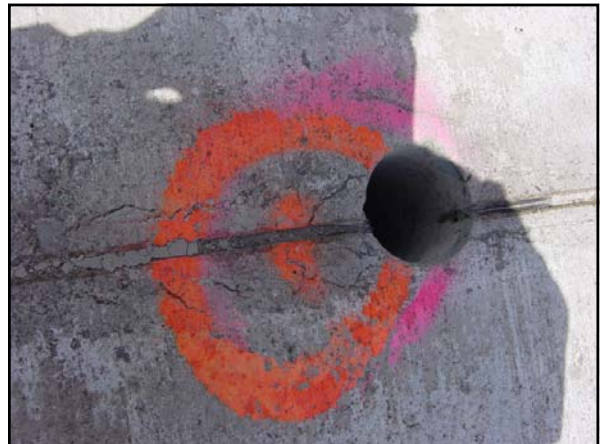
- Construction Defects
  - Dowel Basket Alignment
  - Steel Placement
- Ground Penetrating Radar
- Coring

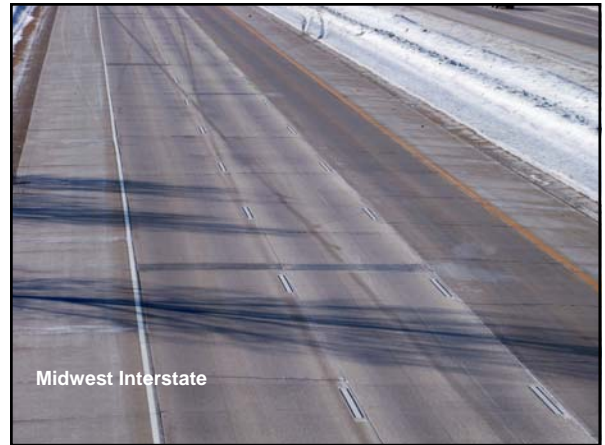
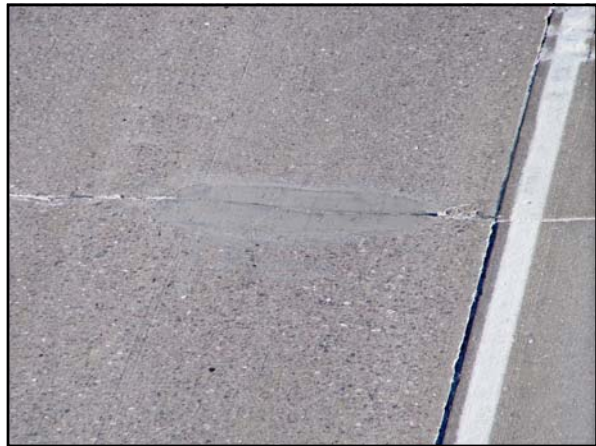
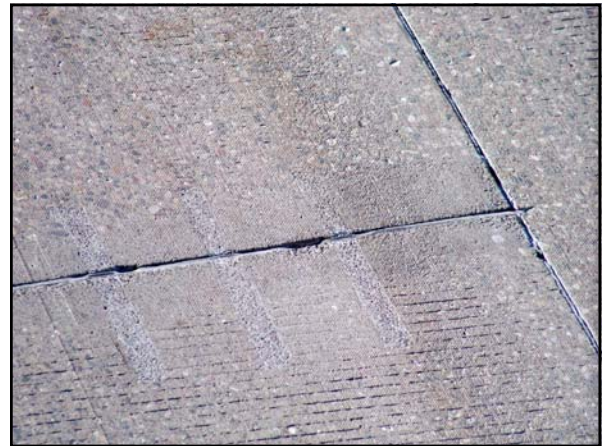
- Design Issues
  - Joint Spacing
  - Undoweled

Falling Weight Deflectometer  
Coring
